TEST REPORT

Report No. : HLO0214A/2007

Product Description: Twin-wheel castor
Style/ Item No.: HT3140

Test Requested:
Caster Durability test

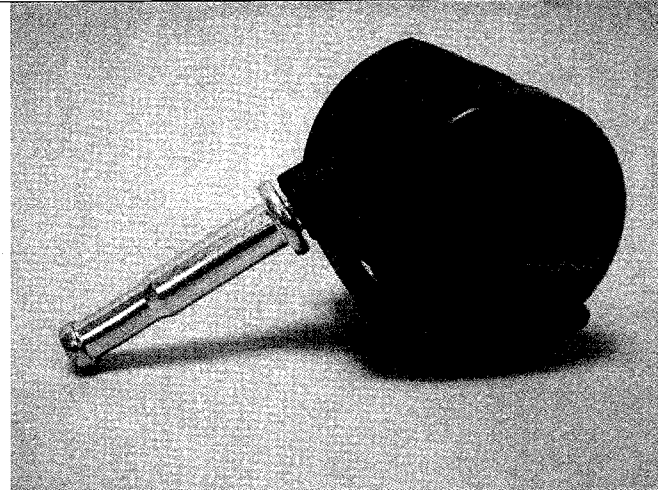
Photo "A" : Appearance of sample

No visual broken or separated was found on the two wheel bodies of the castor after the test.

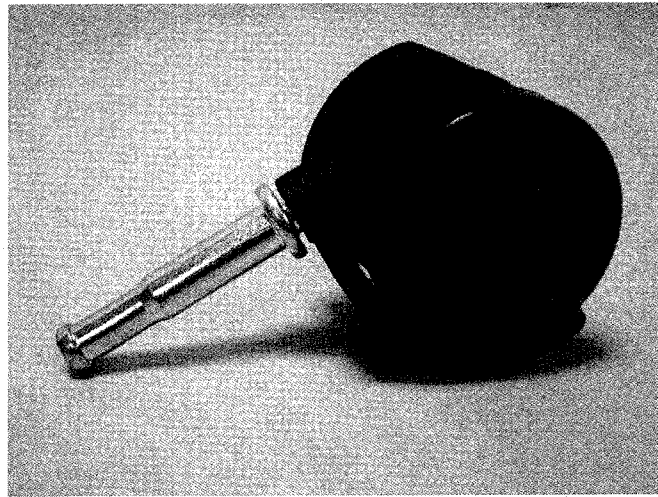
照片 "A"：樣品外觀

產品名稱： Twin-wheel castor

測試後輪子的兩片輪片無明顯分離或破損之情形
