TEST REPORT

Hardline Laboratory Report No.: TH70058A/2024

<u>Product Description:</u> HT-TC01 small plastic dolly <u>Style/Item No.:</u> HT-TC01 small plastic dolly <u>Manufacturer/Vendor:</u> Huntai Plastic Co., Ltd.

<u>Test Requested:</u> Loading test

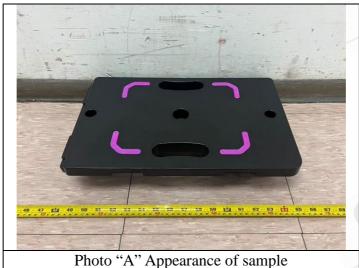
- Picture(s) -

Sample	Test load	Observation
HT-TC01 small plastic dolly	150 kgf	After testing, the sample was not damaged.
